Appendix E

Pavement Condition Assessment and Photographs

Reds Meadow Road Improvements FTFS 03S11(1) Madera County, California	
PAVEMENT CONDITION CATEGORIES	
January 2021	100062-003
SHANNON & WILSON, INC. <small>GEOTECHNICAL AND ENVIRONMENTAL CONSULTANTS</small>	
FIG. E-1

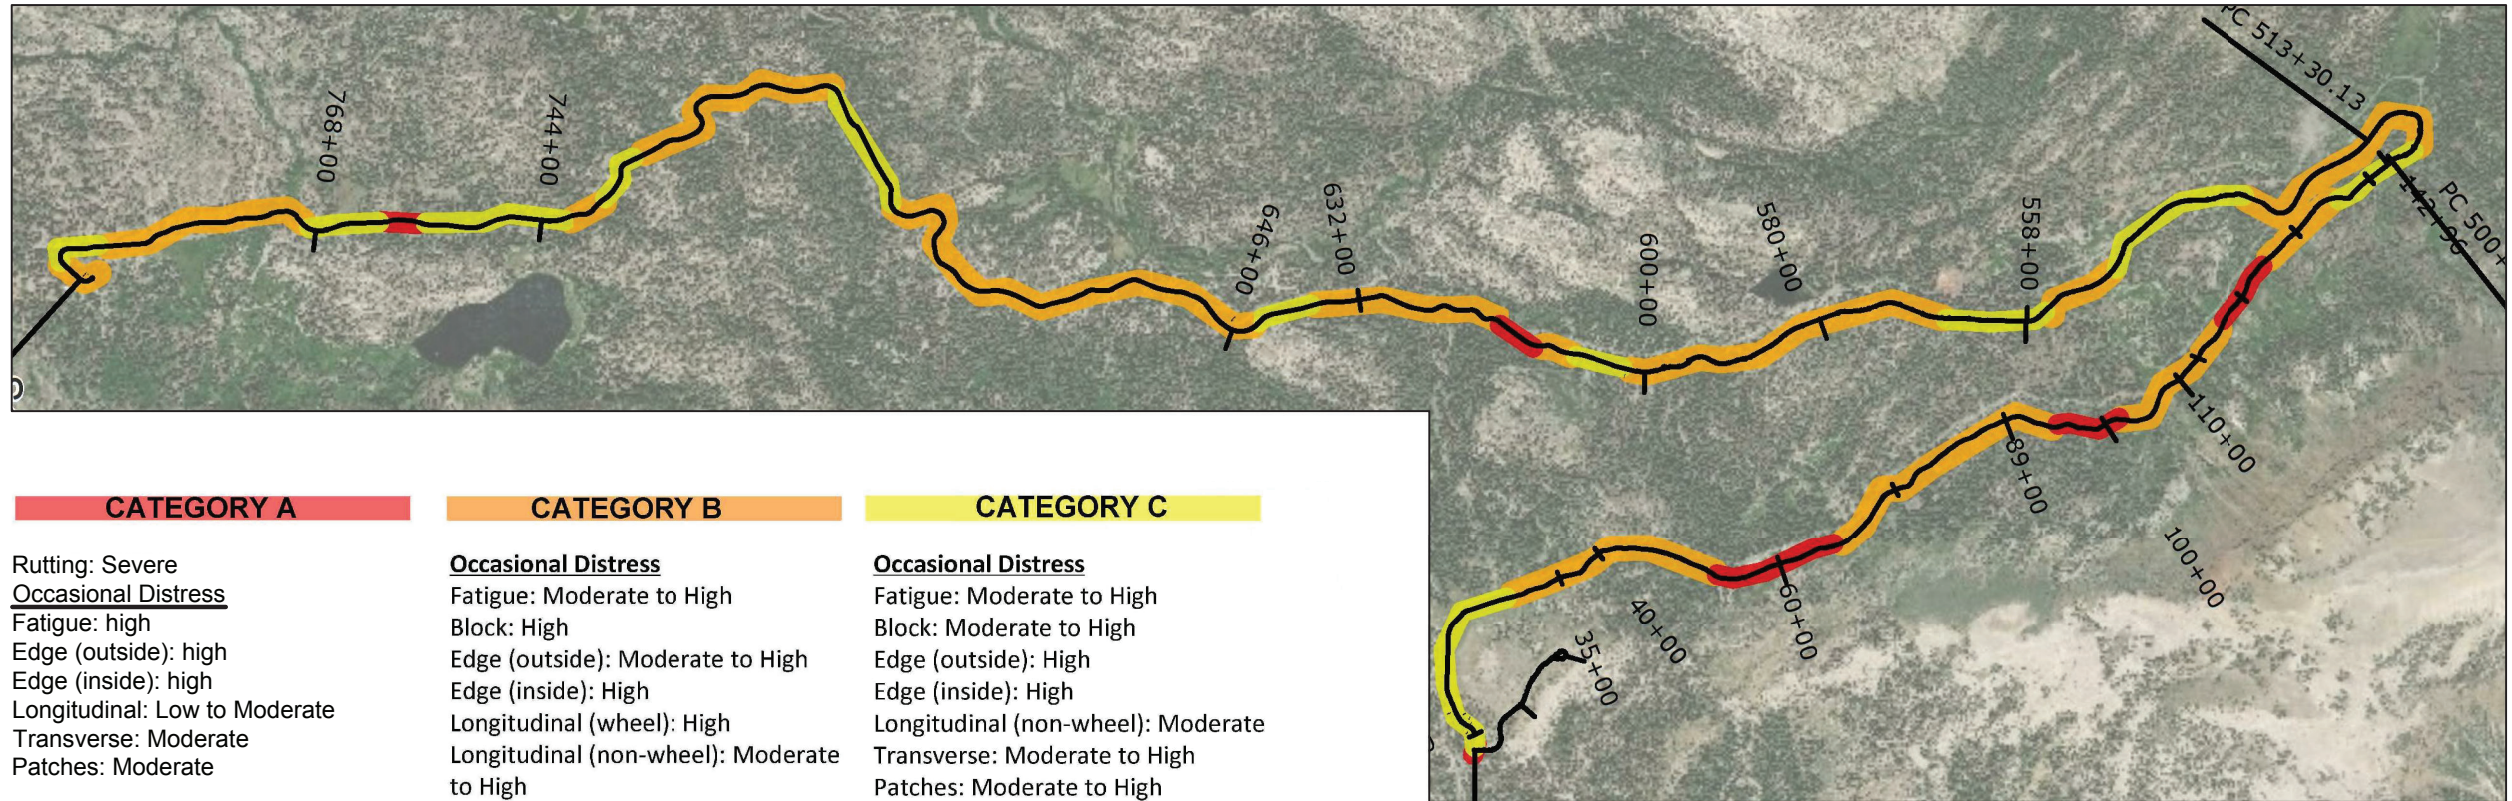
CATEGORY A	CATEGORY B	CATEGORY C
Rutting: Severe <u>Occasional Distress</u> Fatigue: high Edge (outside): high Edge (inside): high Longitudinal: Low to Moderate Transverse: Moderate Patches: Moderate	Occasional Distress Fatigue: Moderate to High Block: High Edge (outside): Moderate to High Edge (inside): High Longitudinal (wheel): High Longitudinal (non-wheel): Moderate to High Transverse: High Patches: Low to Moderate Potholes: Moderate to High Rutting: present/occasional Raveling: some raveling in high fatigue areas Drop Off: present/occasional	Occasional Distress Fatigue: Moderate to High Block: Moderate to High Edge (outside): High Edge (inside): High Longitudinal (non-wheel): Moderate Transverse: Moderate to High Patches: Moderate to High Potholes: Low Raveling: in some high fatigue areas

The category descriptions provide the distress type and level of severity.

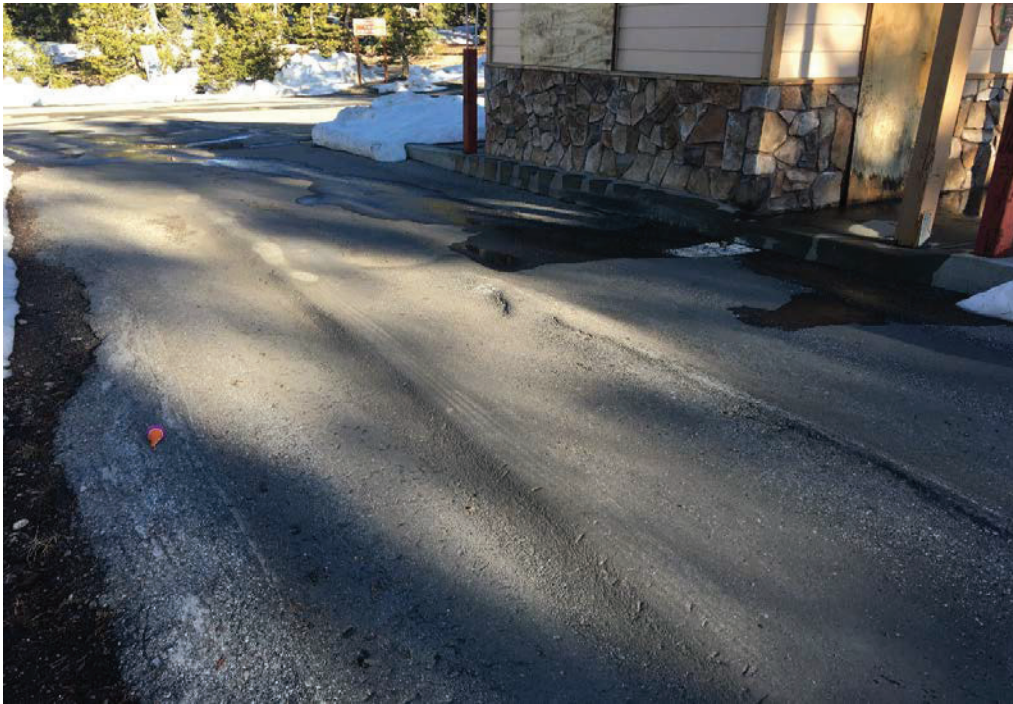
Photograph 1. Severe rutting at station 0+00. View looking north.

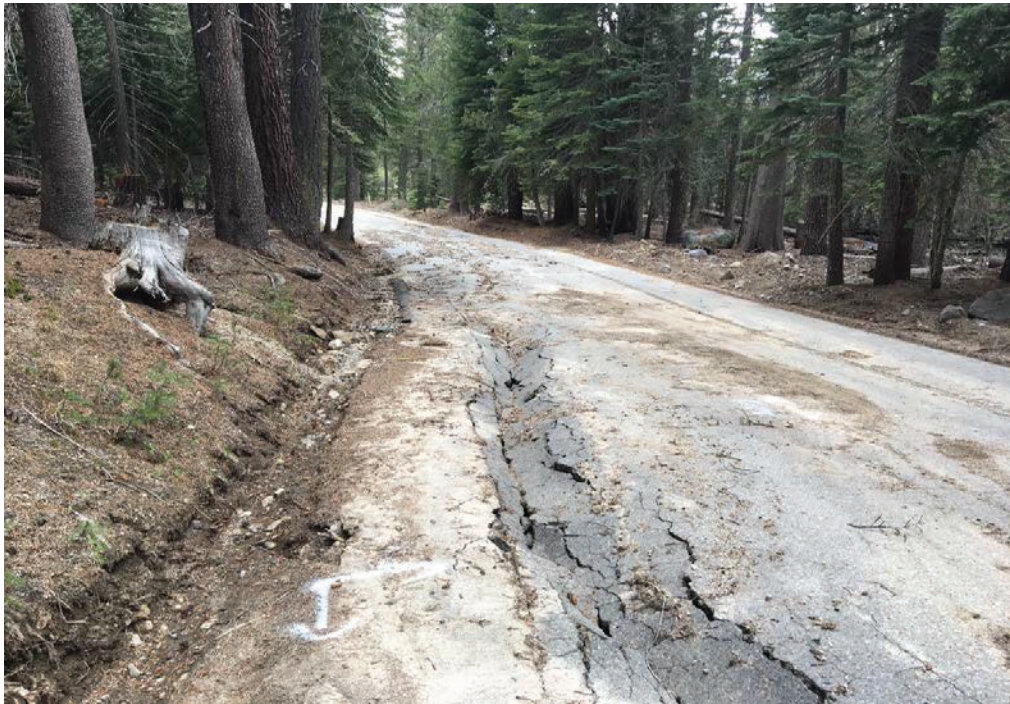
Photograph 2. Severe rutting at station 758+00. View looking west.

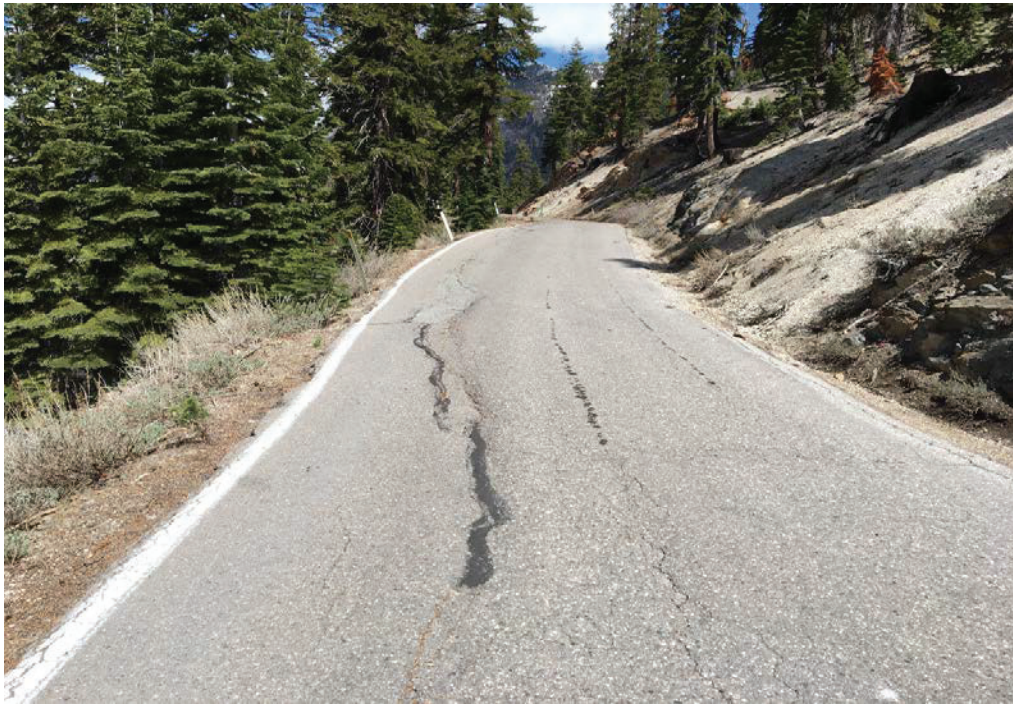
Photograph 3. Moderate severity longitudinal cracking at station 84+50 View looking northeast.

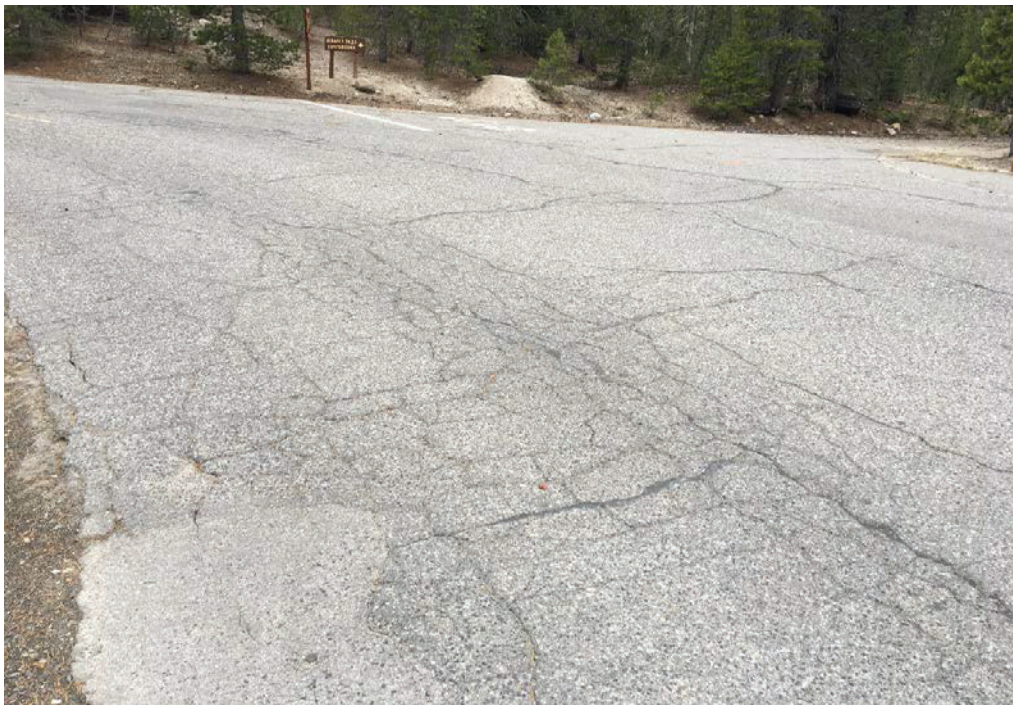
Photograph 4. Moderate to high severity block and fatigue cracking at station 685+00. View looking west.

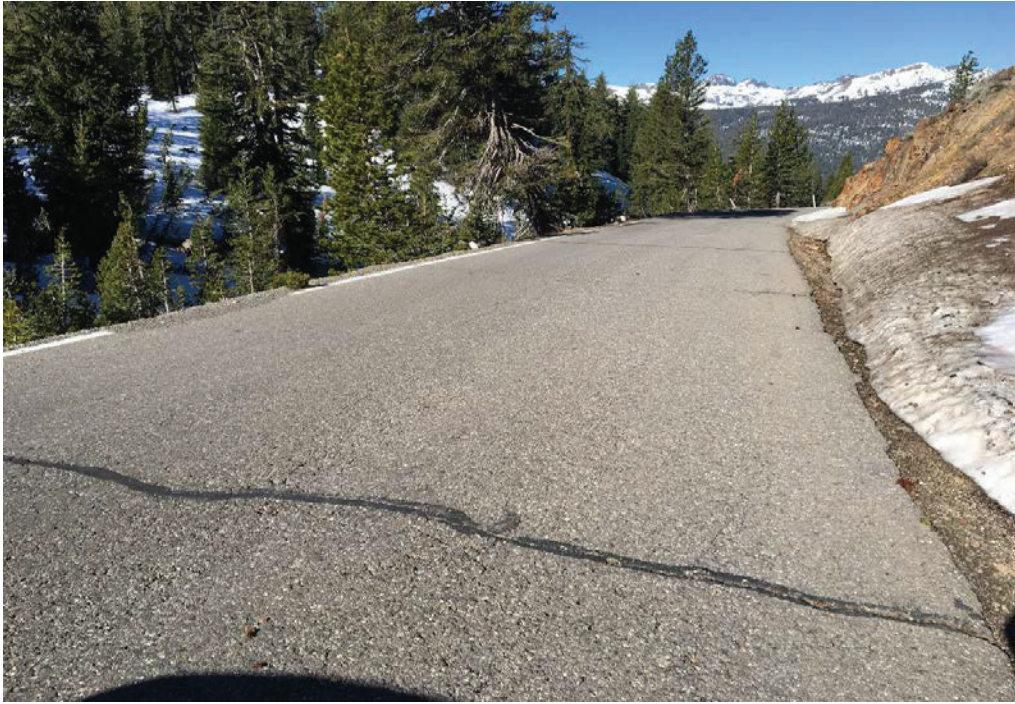
Photograph 5. Moderate severity transverse cracking at station 13+50. View looking southwest.

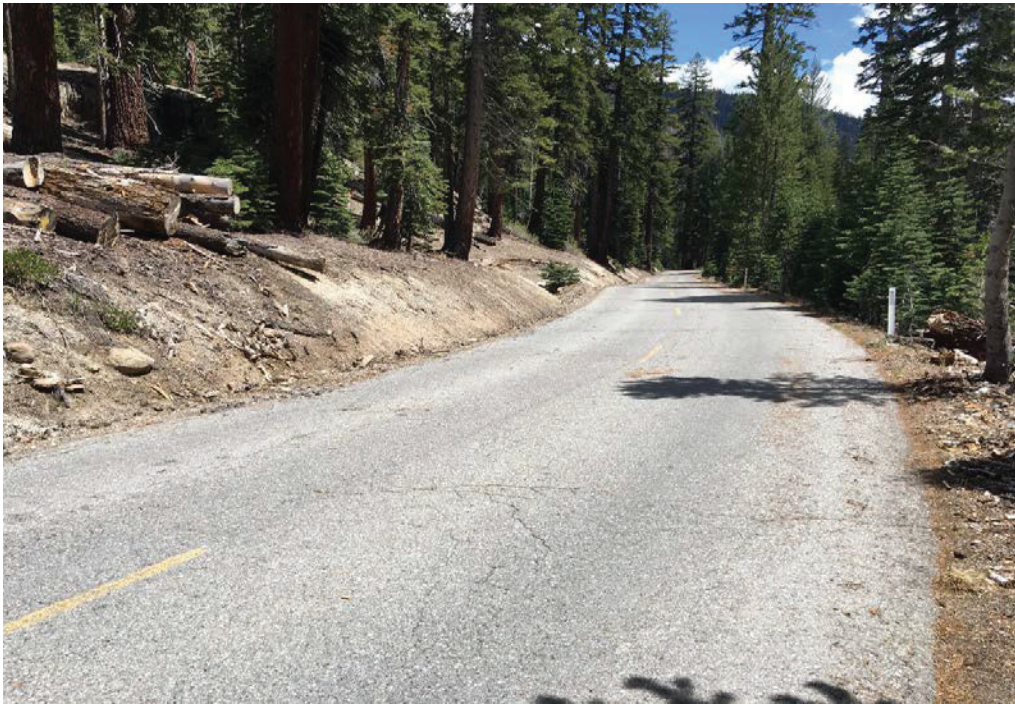
Photograph 6. Low severity fatigue cracking and rutting at station 358+00. View looking south.
