GEOTECHNICAL INVESTIGATION REPORT

TAHOE VALLEY STORMWATER AND GREENBELT IMPROVEMENTS South Lake Tahoe, California

LUMOS and ASSOCIATES, INC.

> October, 2016 JN: 8937.000

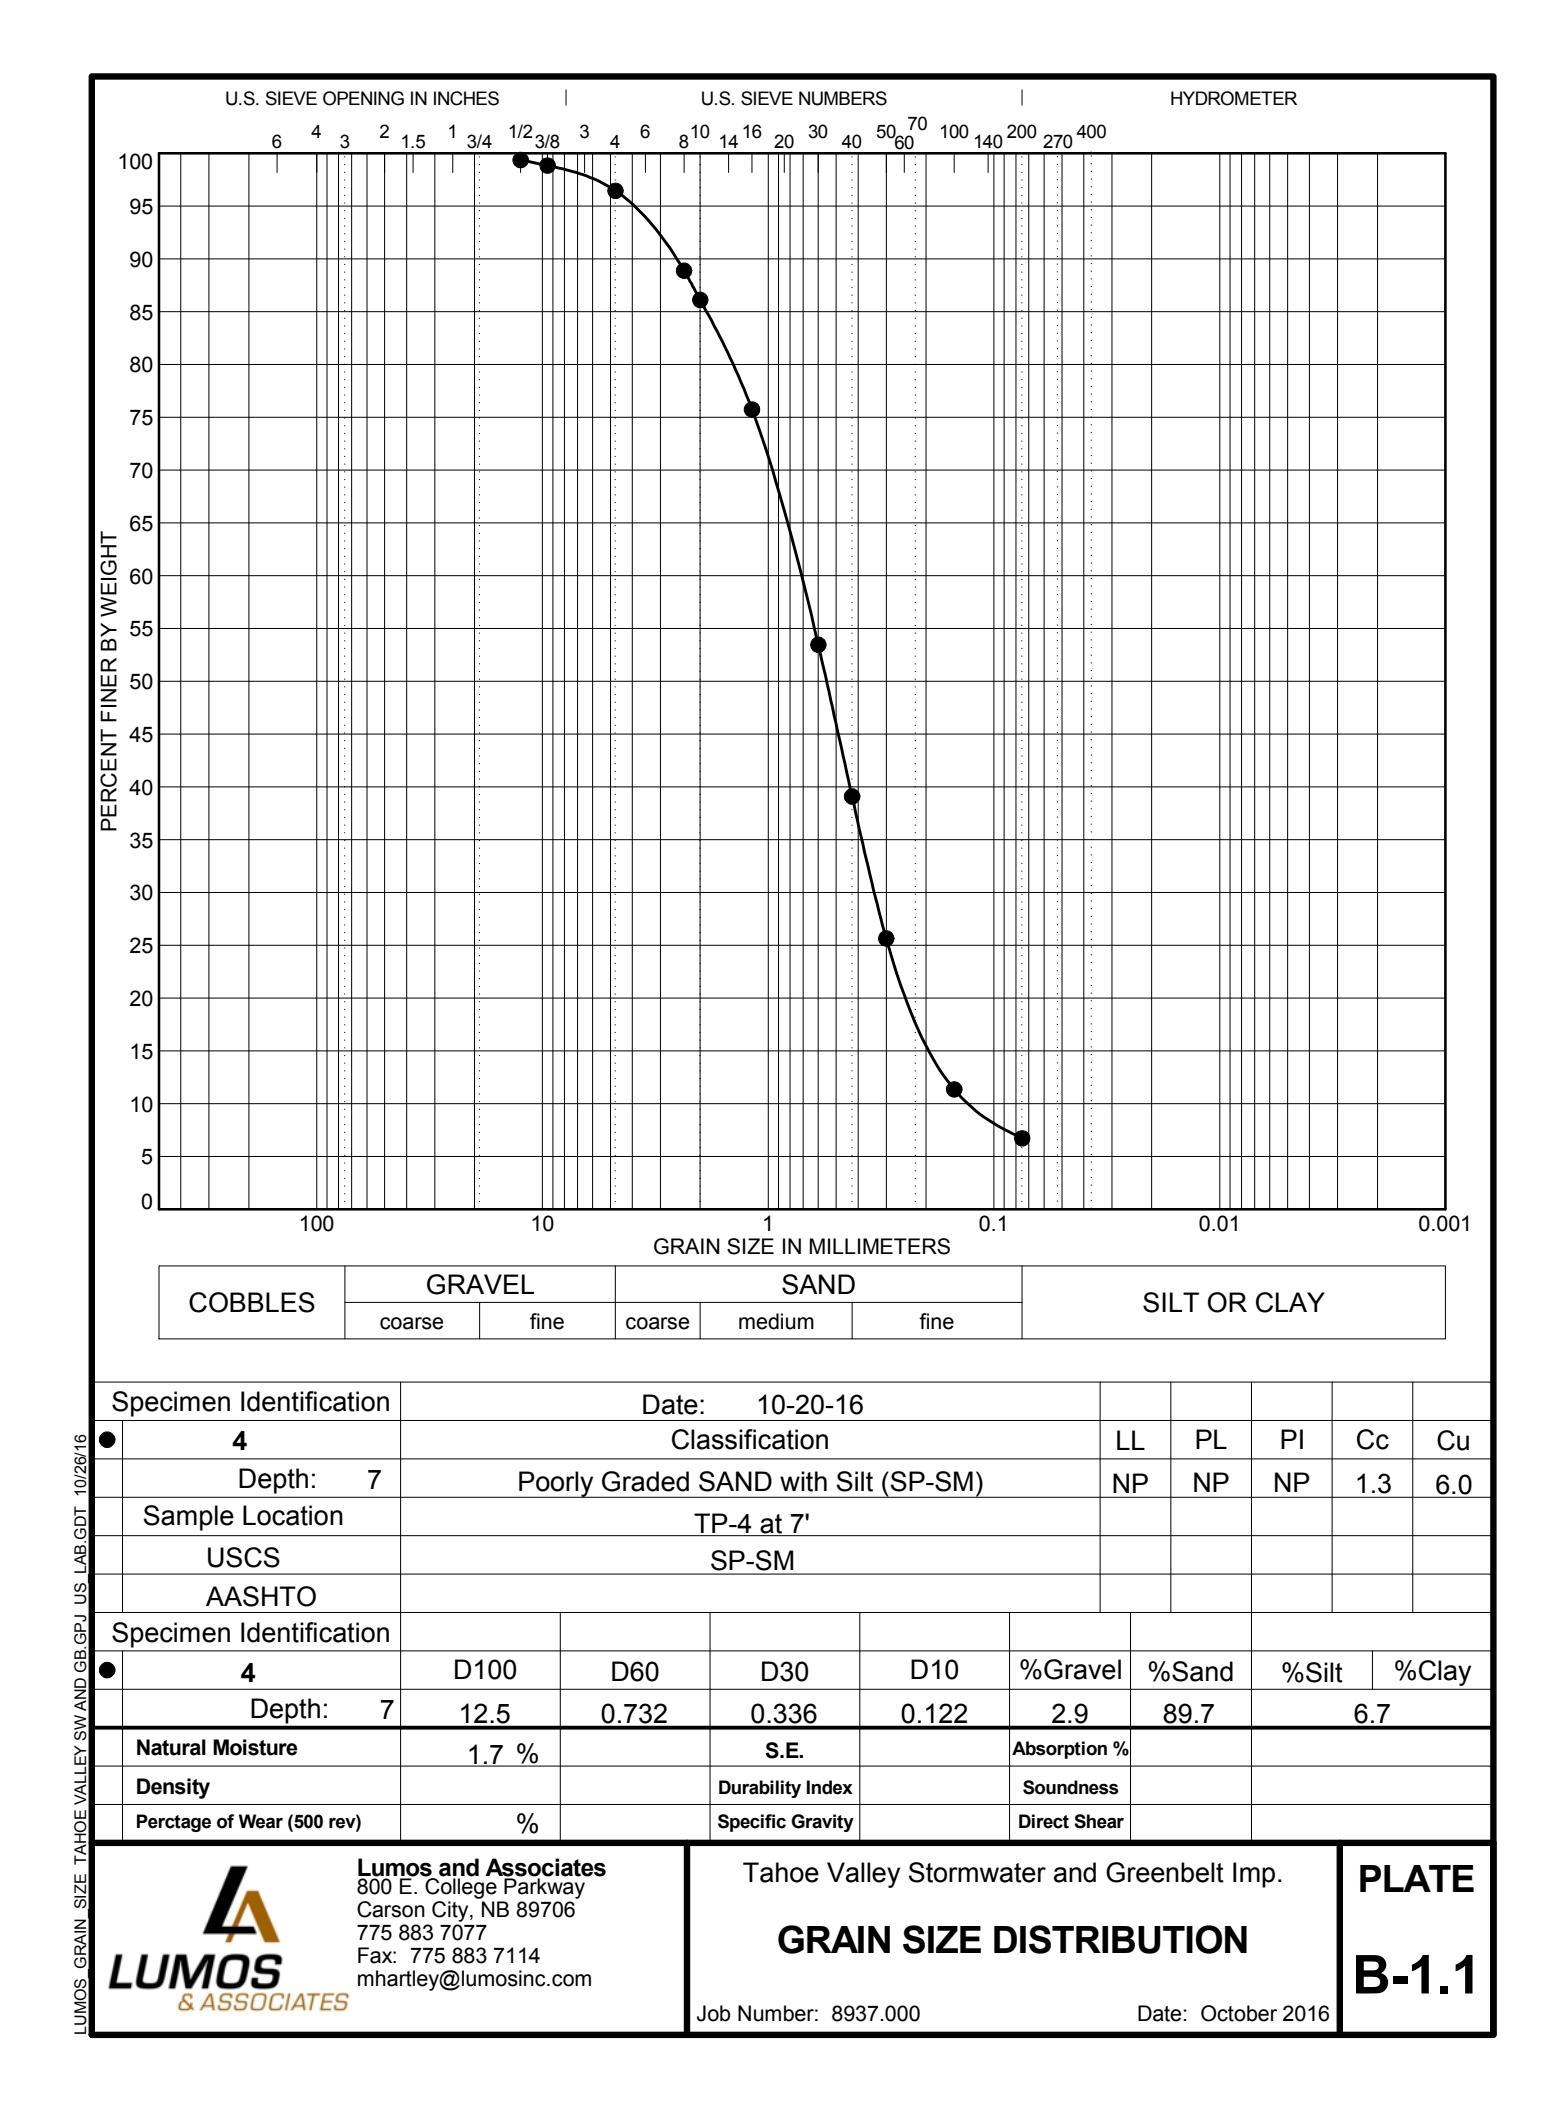
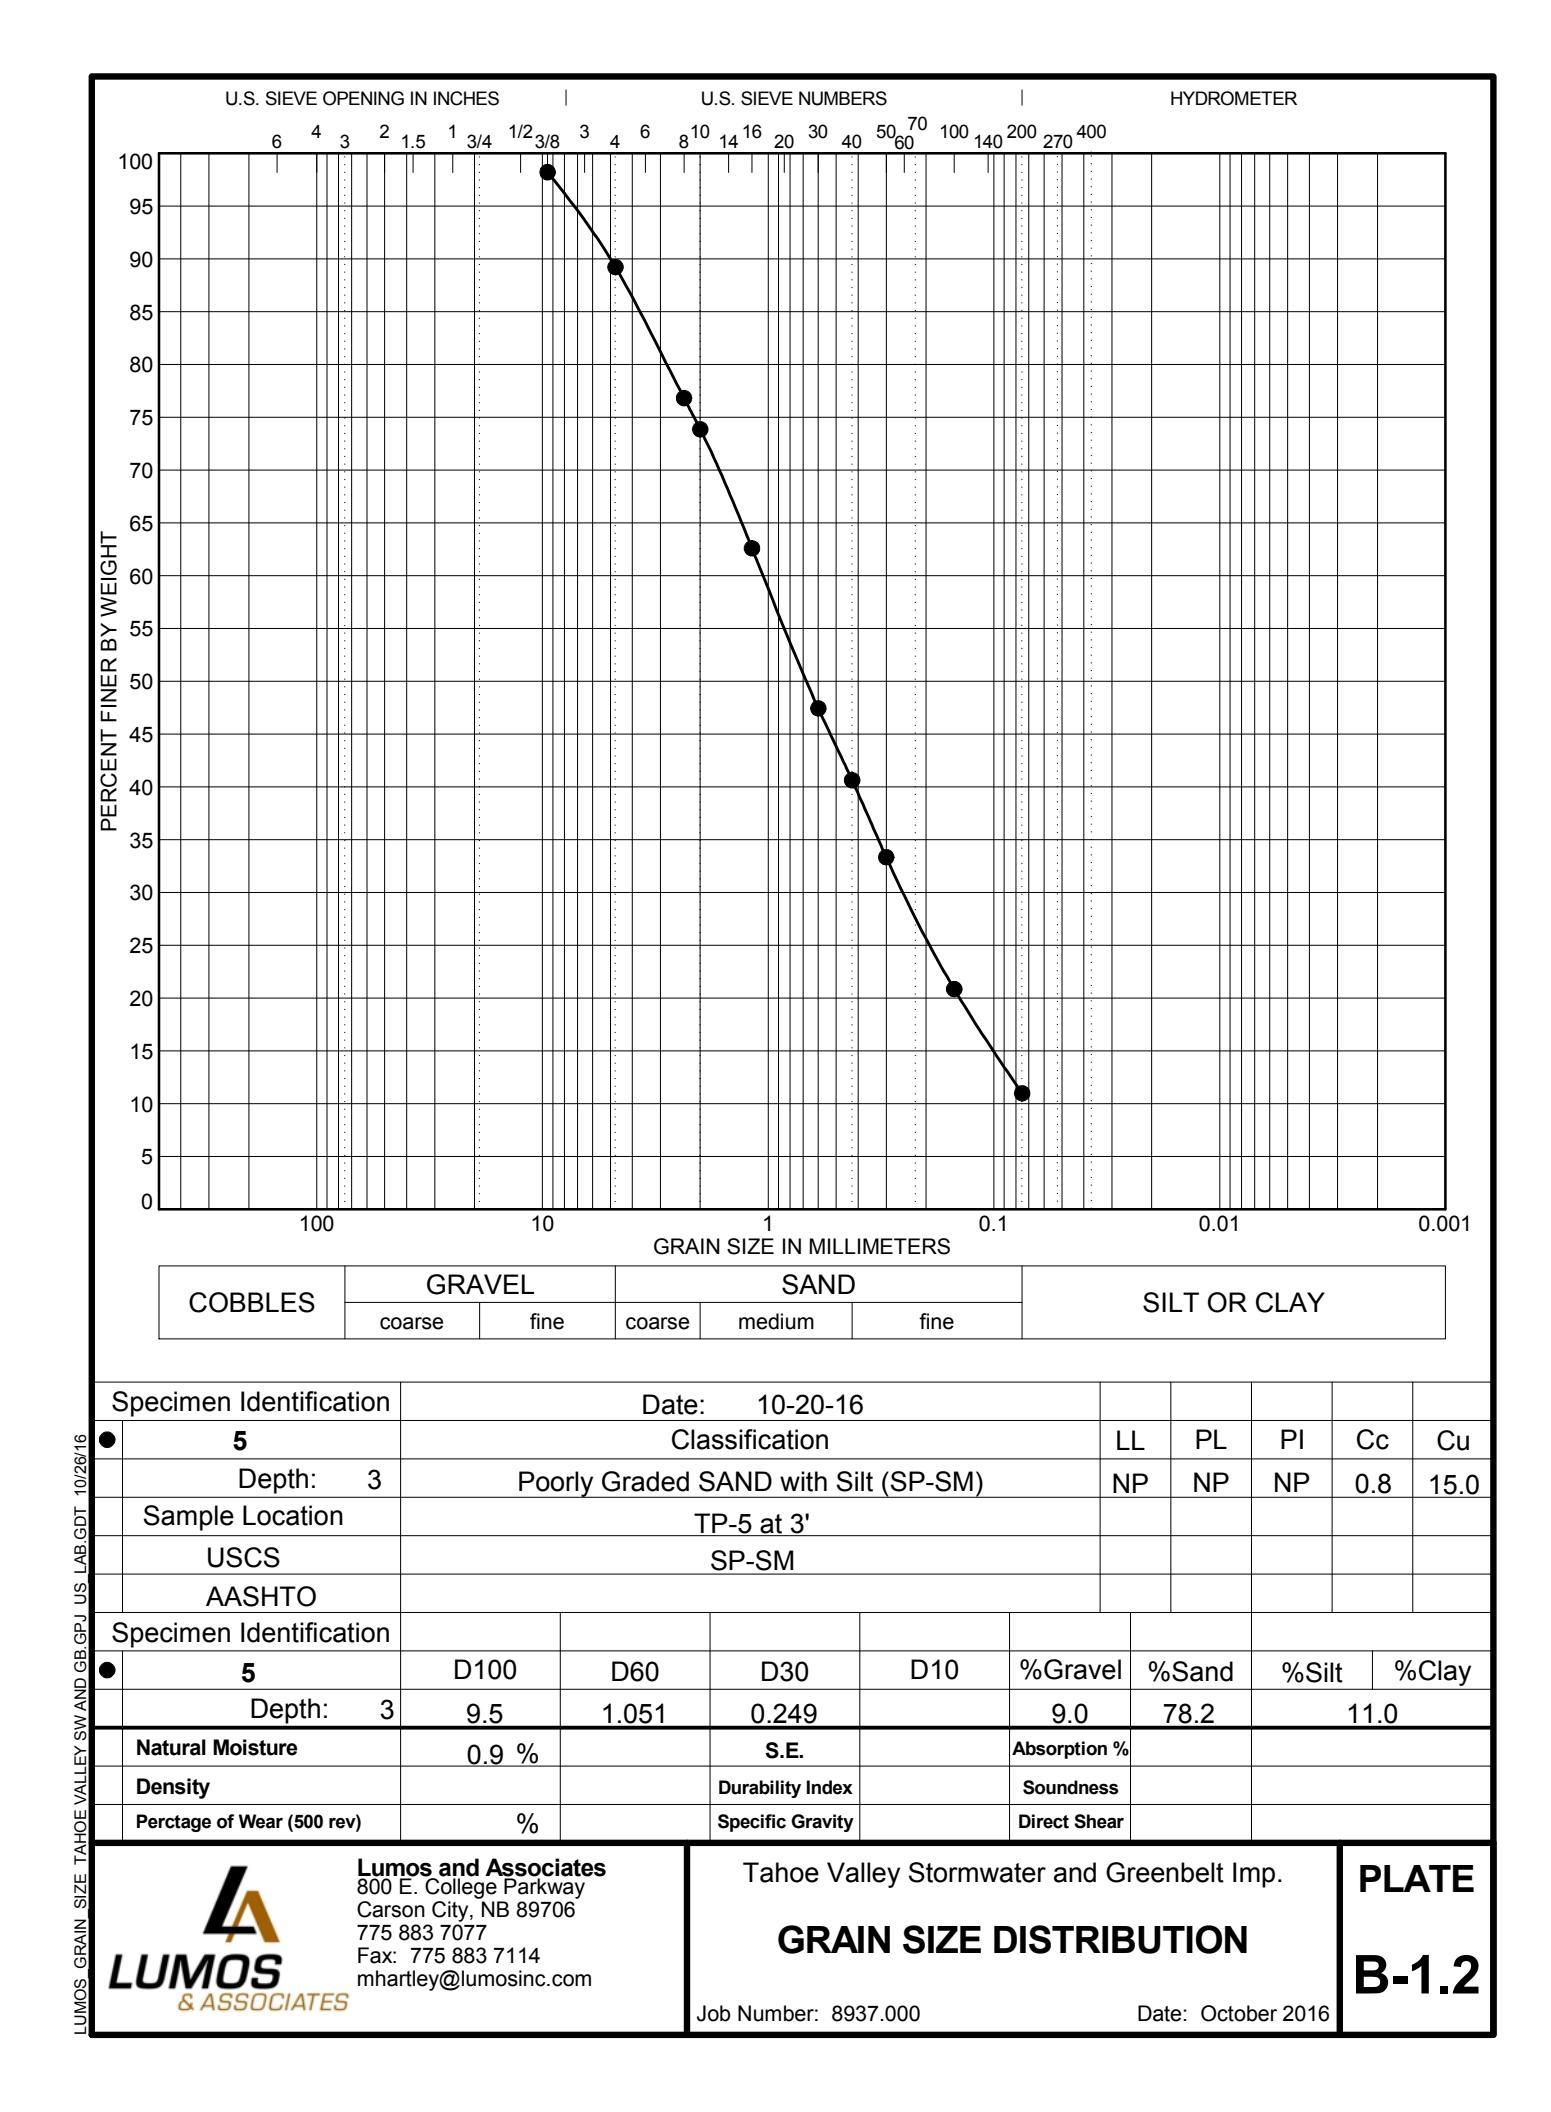
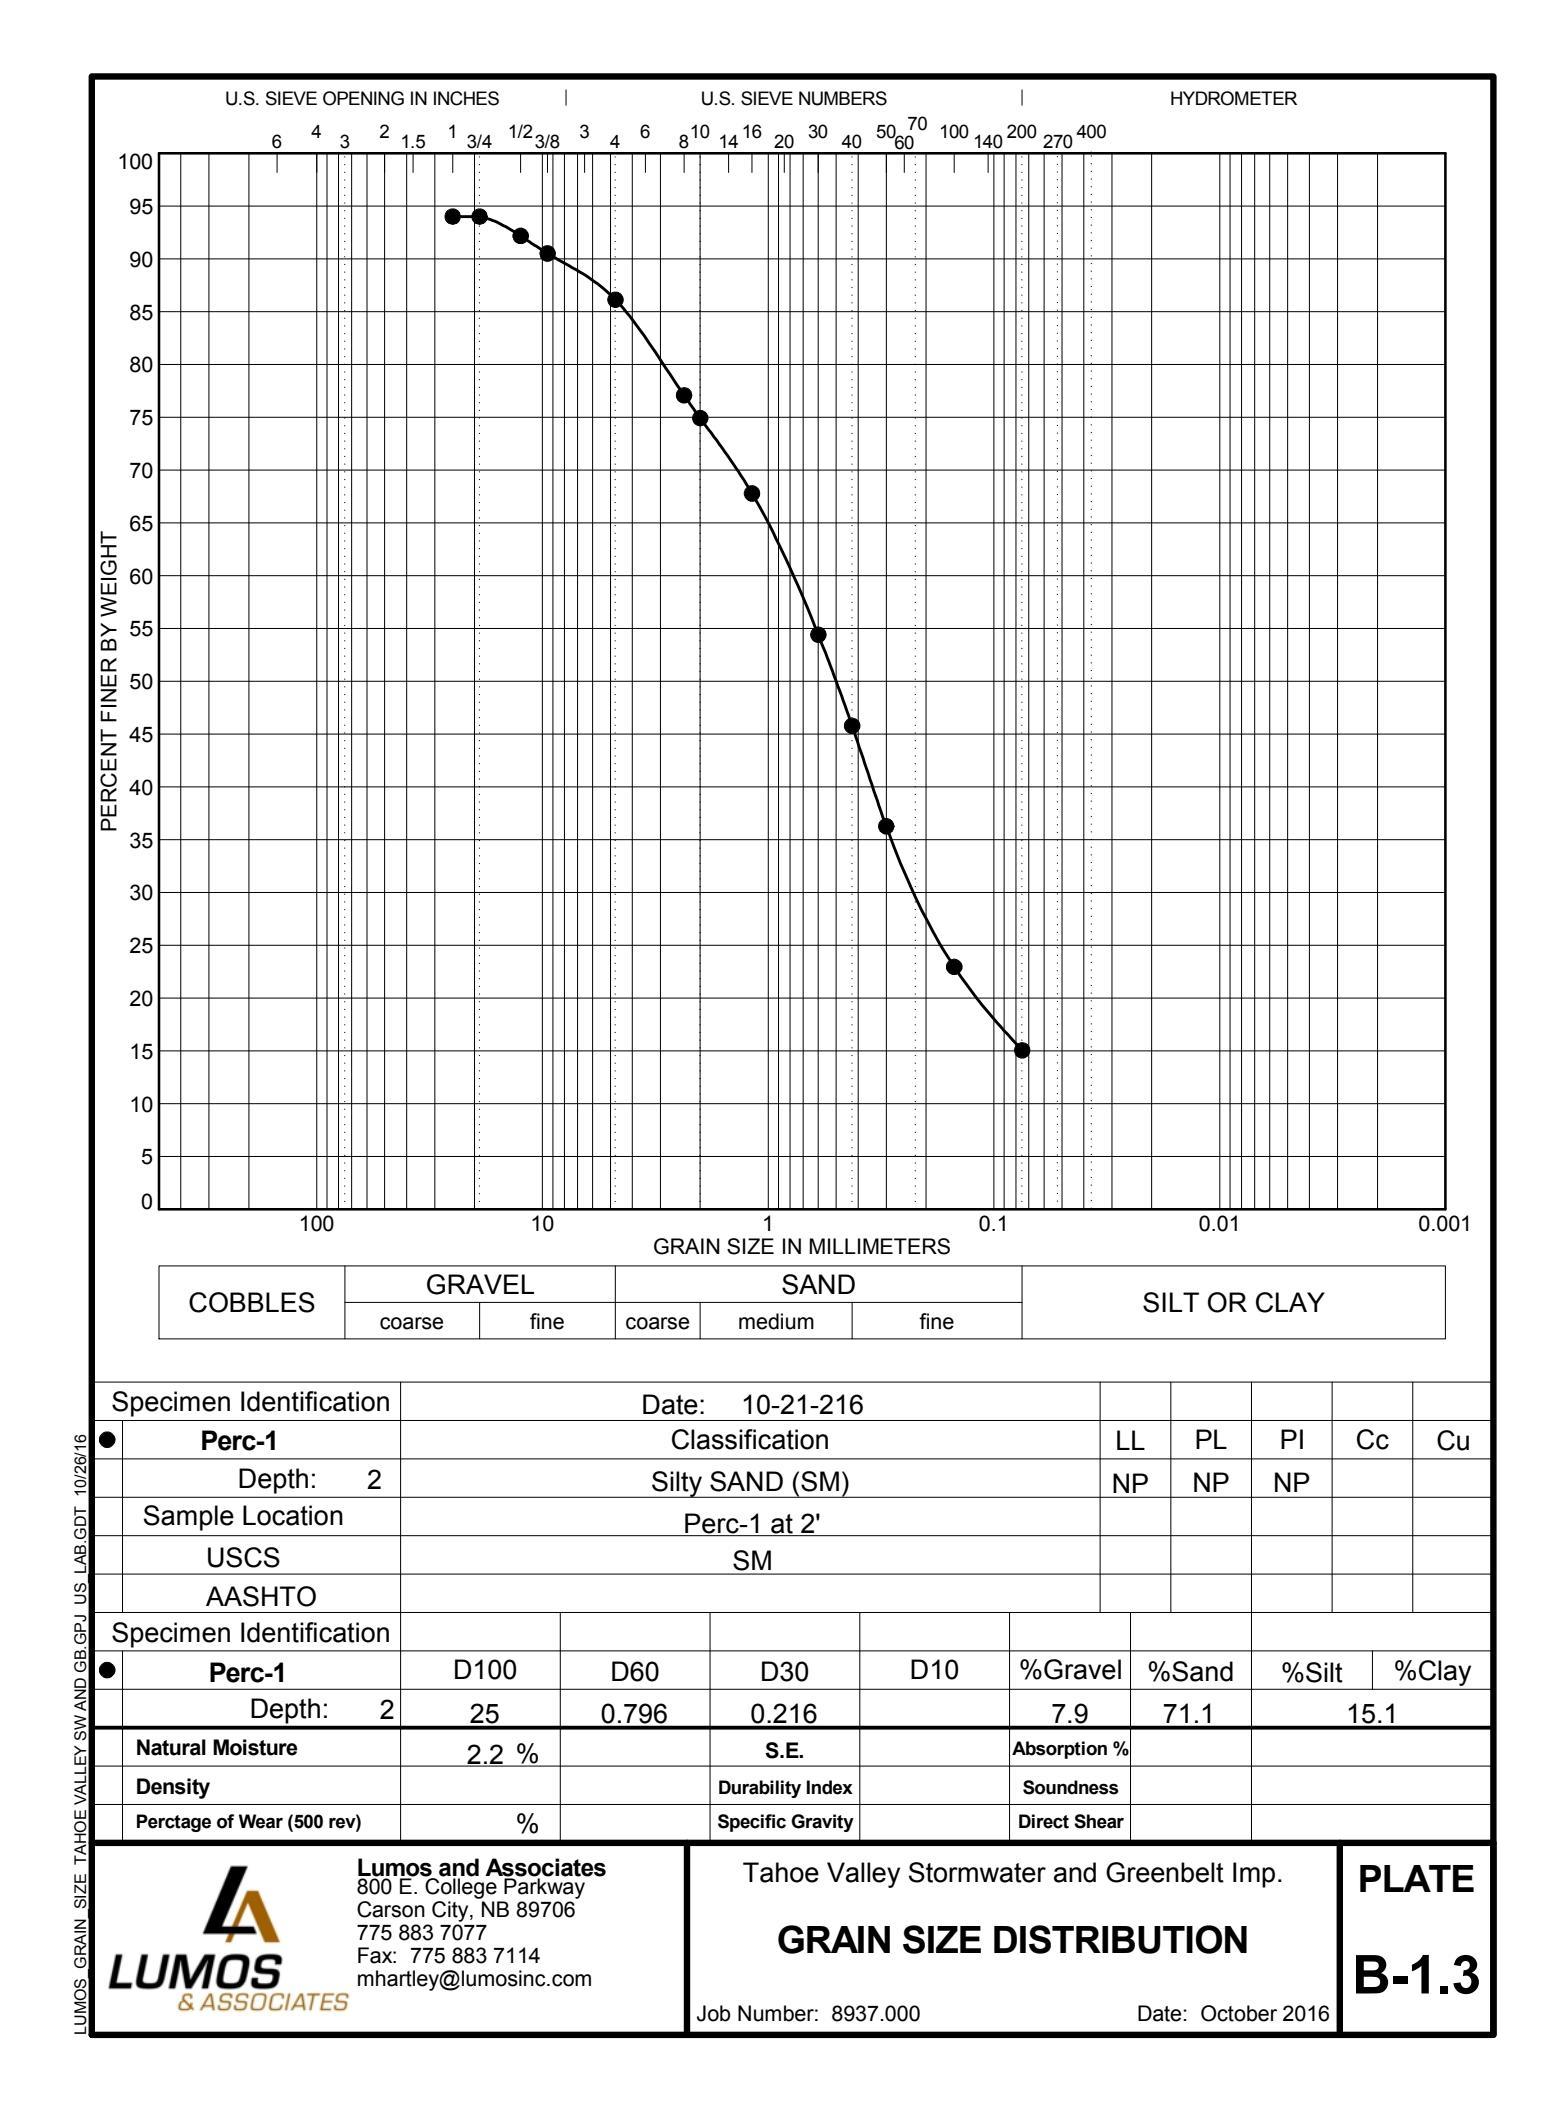
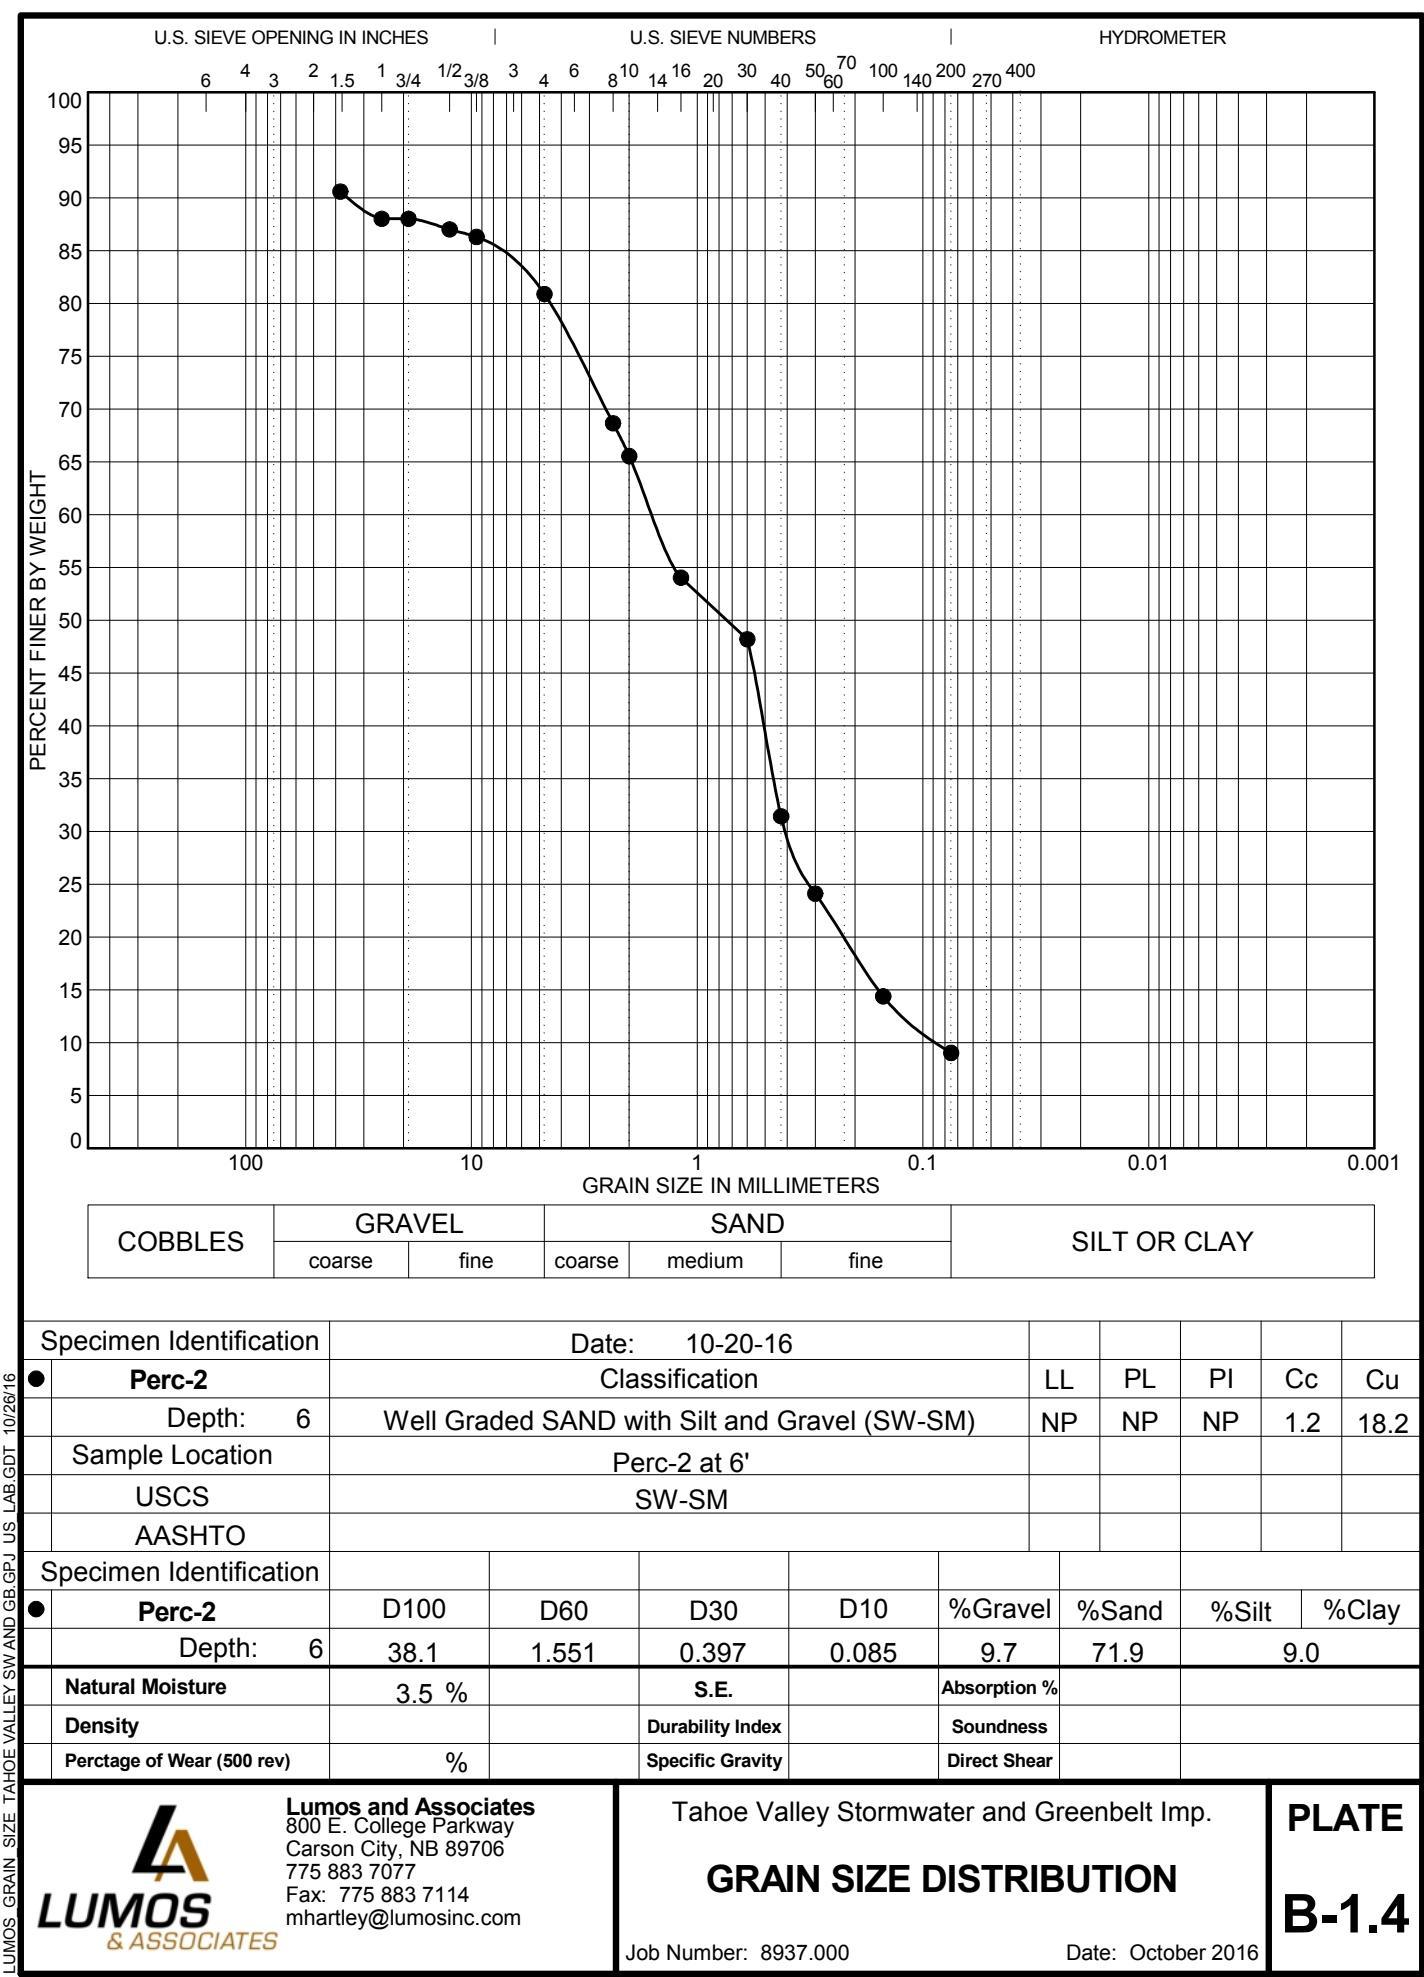
US_LAB.GDT GP.J AND GR MS: Ъ VALL TAHOE SIZE GRAIN

Individual laboratory test results are presented in Appendix B as Plates B-1 through B-5. Laboratory testing was performed per ASTM standards, except when test procedures are briefly described and no ASTM standard is specifically referenced in the report. Atterberg limits were determined using the dry method of preparation (Plate B-2). Special testing conducted for this project is described below.
